TECHNICAL PUBLICATION # 79-2

June 1979

IMPROVEMENT OF THE CANAL-AQUIFER
FLOW REGIME IN THE C-1N BASIN

Resource Planning Department
South Florida Water Management District
West Palm Beach, Florida 33402

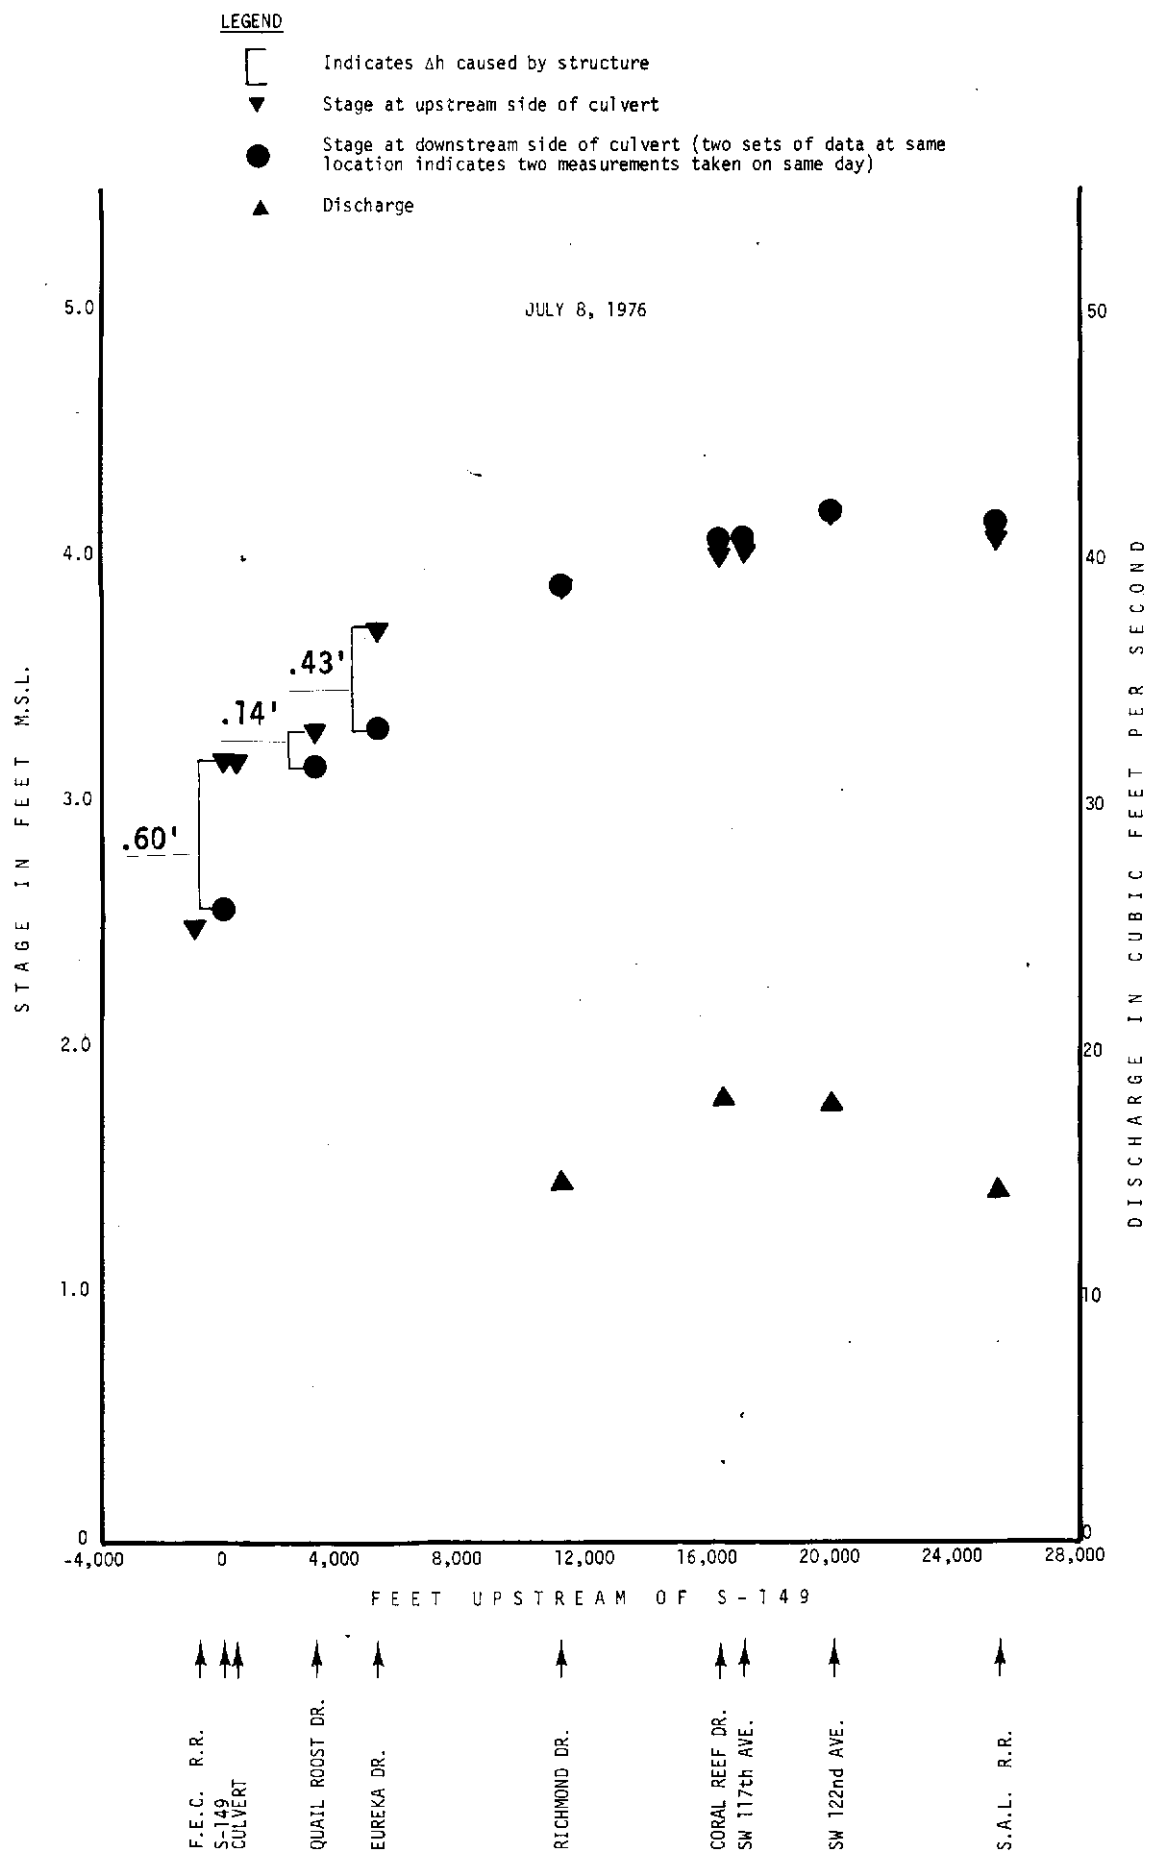
Figure 15. Stage and discharge profiles on July 8, 1976.

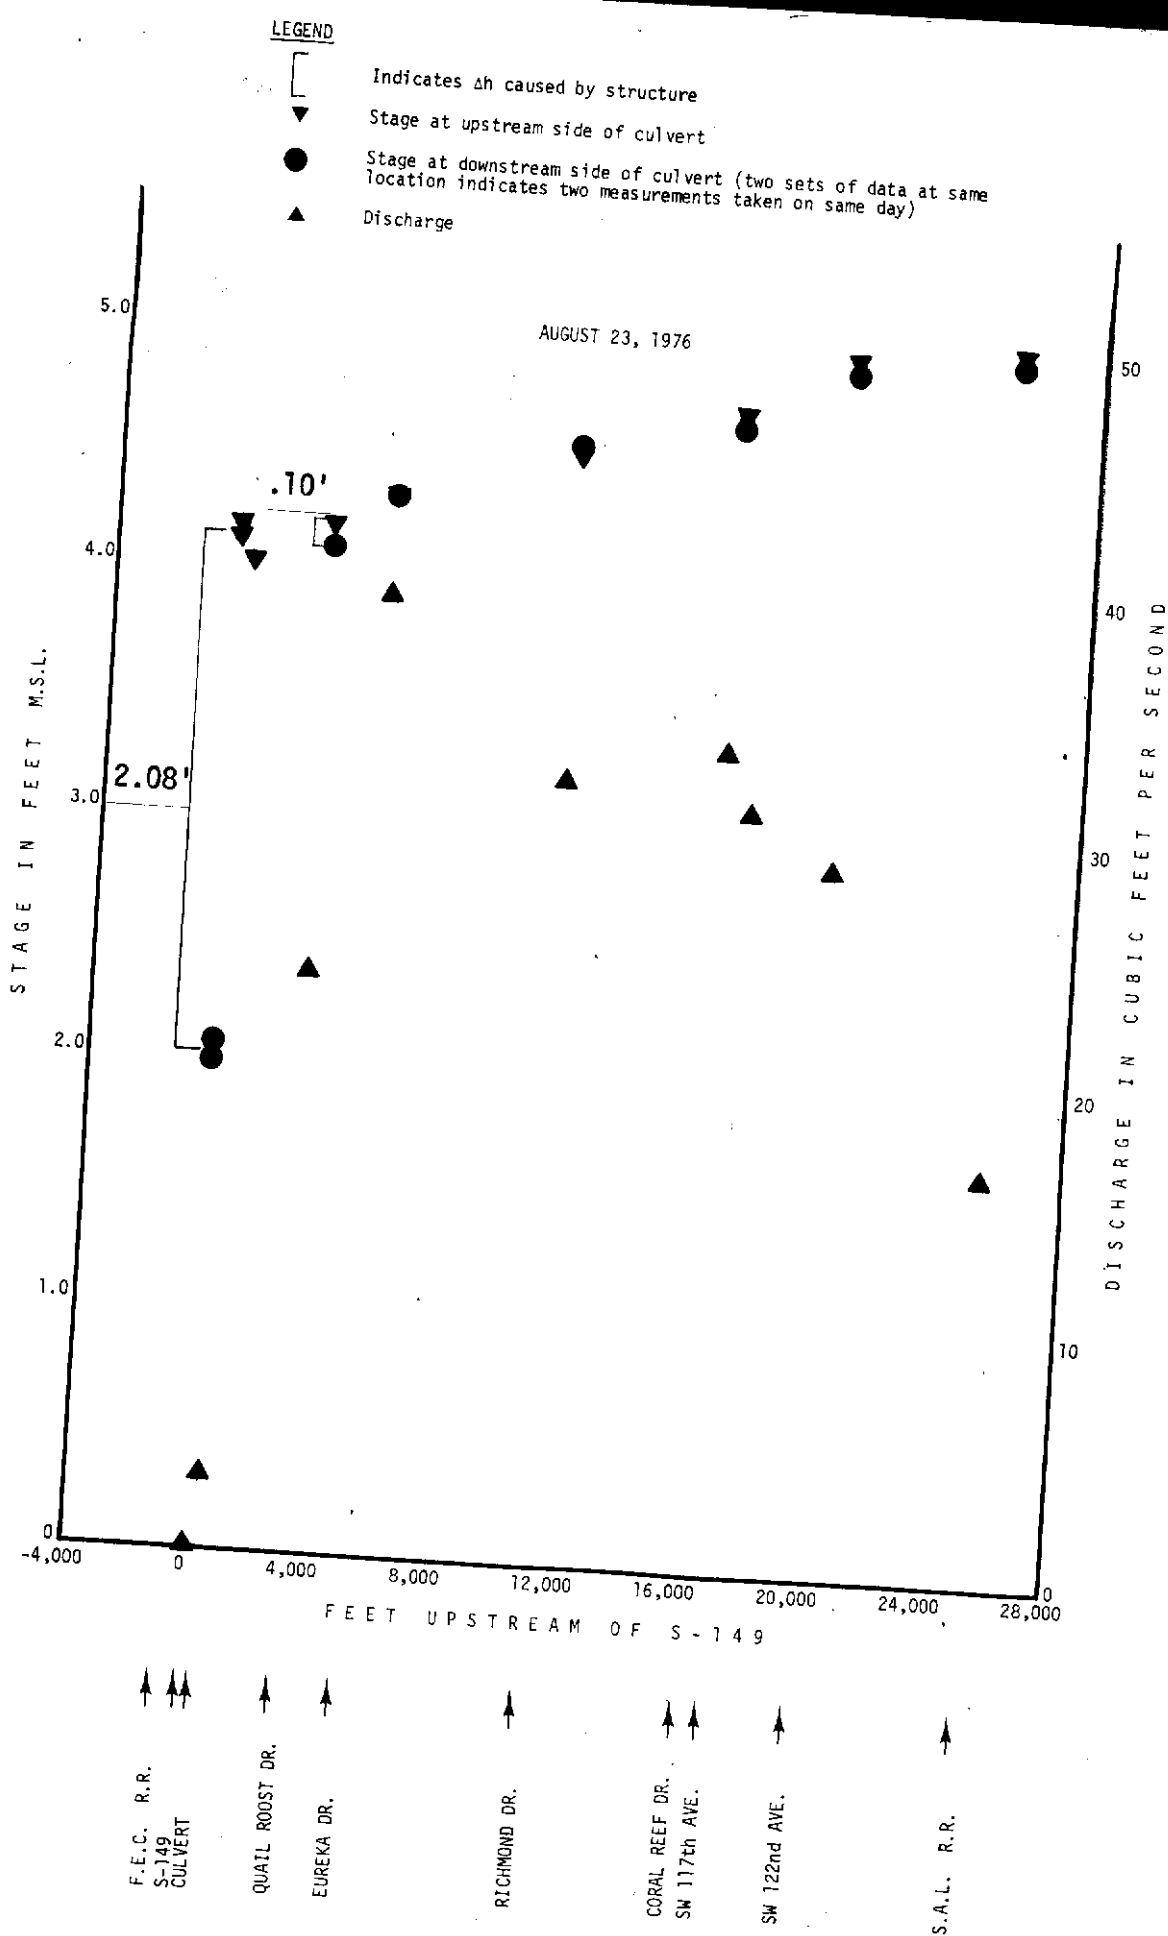
Figure 16. Stage and discharge profiles on August 23, 1976.

Generally, discharge measurements made when the temporary structures were operational indicate zero discharge at the structures. Two exceptions occurred at Quail Roost Drive on March 30 and August 23, 1976, when the

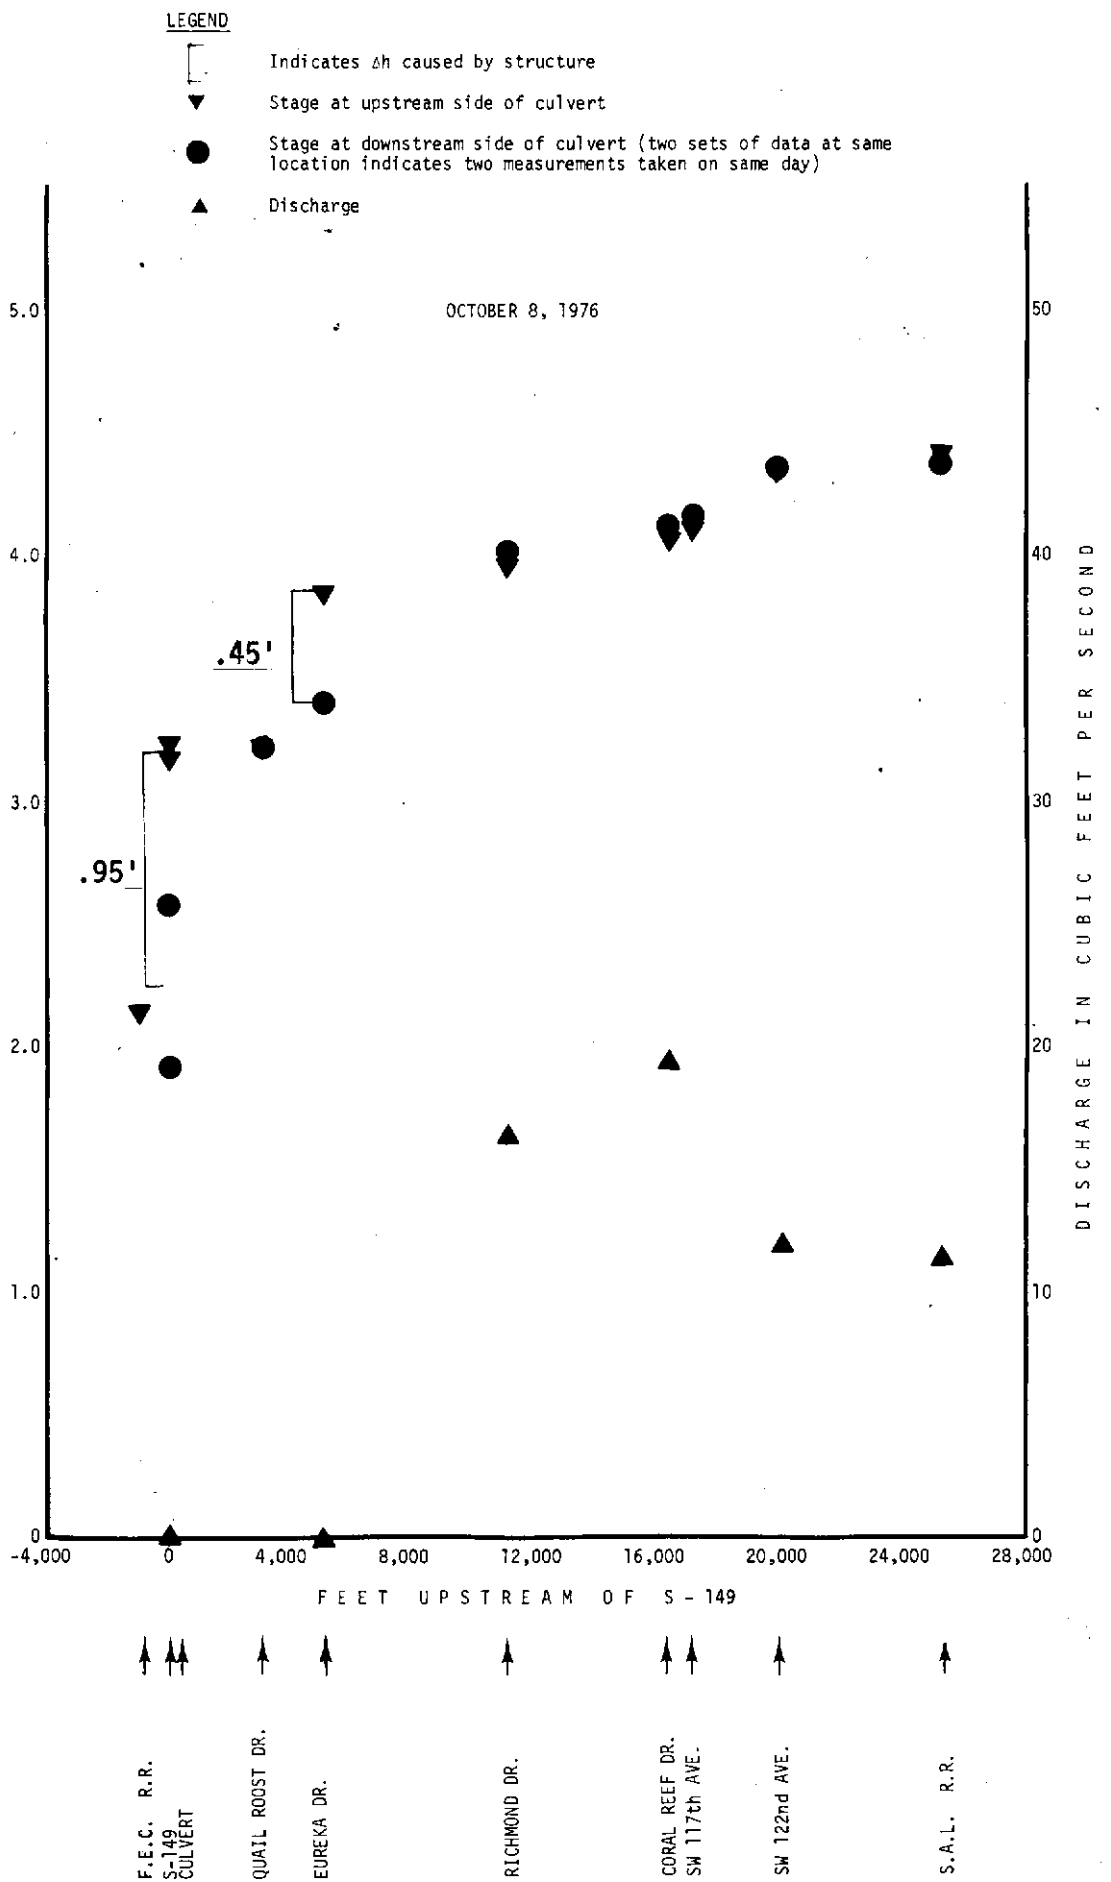
Figure 17. Stage and discharge profiles on October 8, 1976.

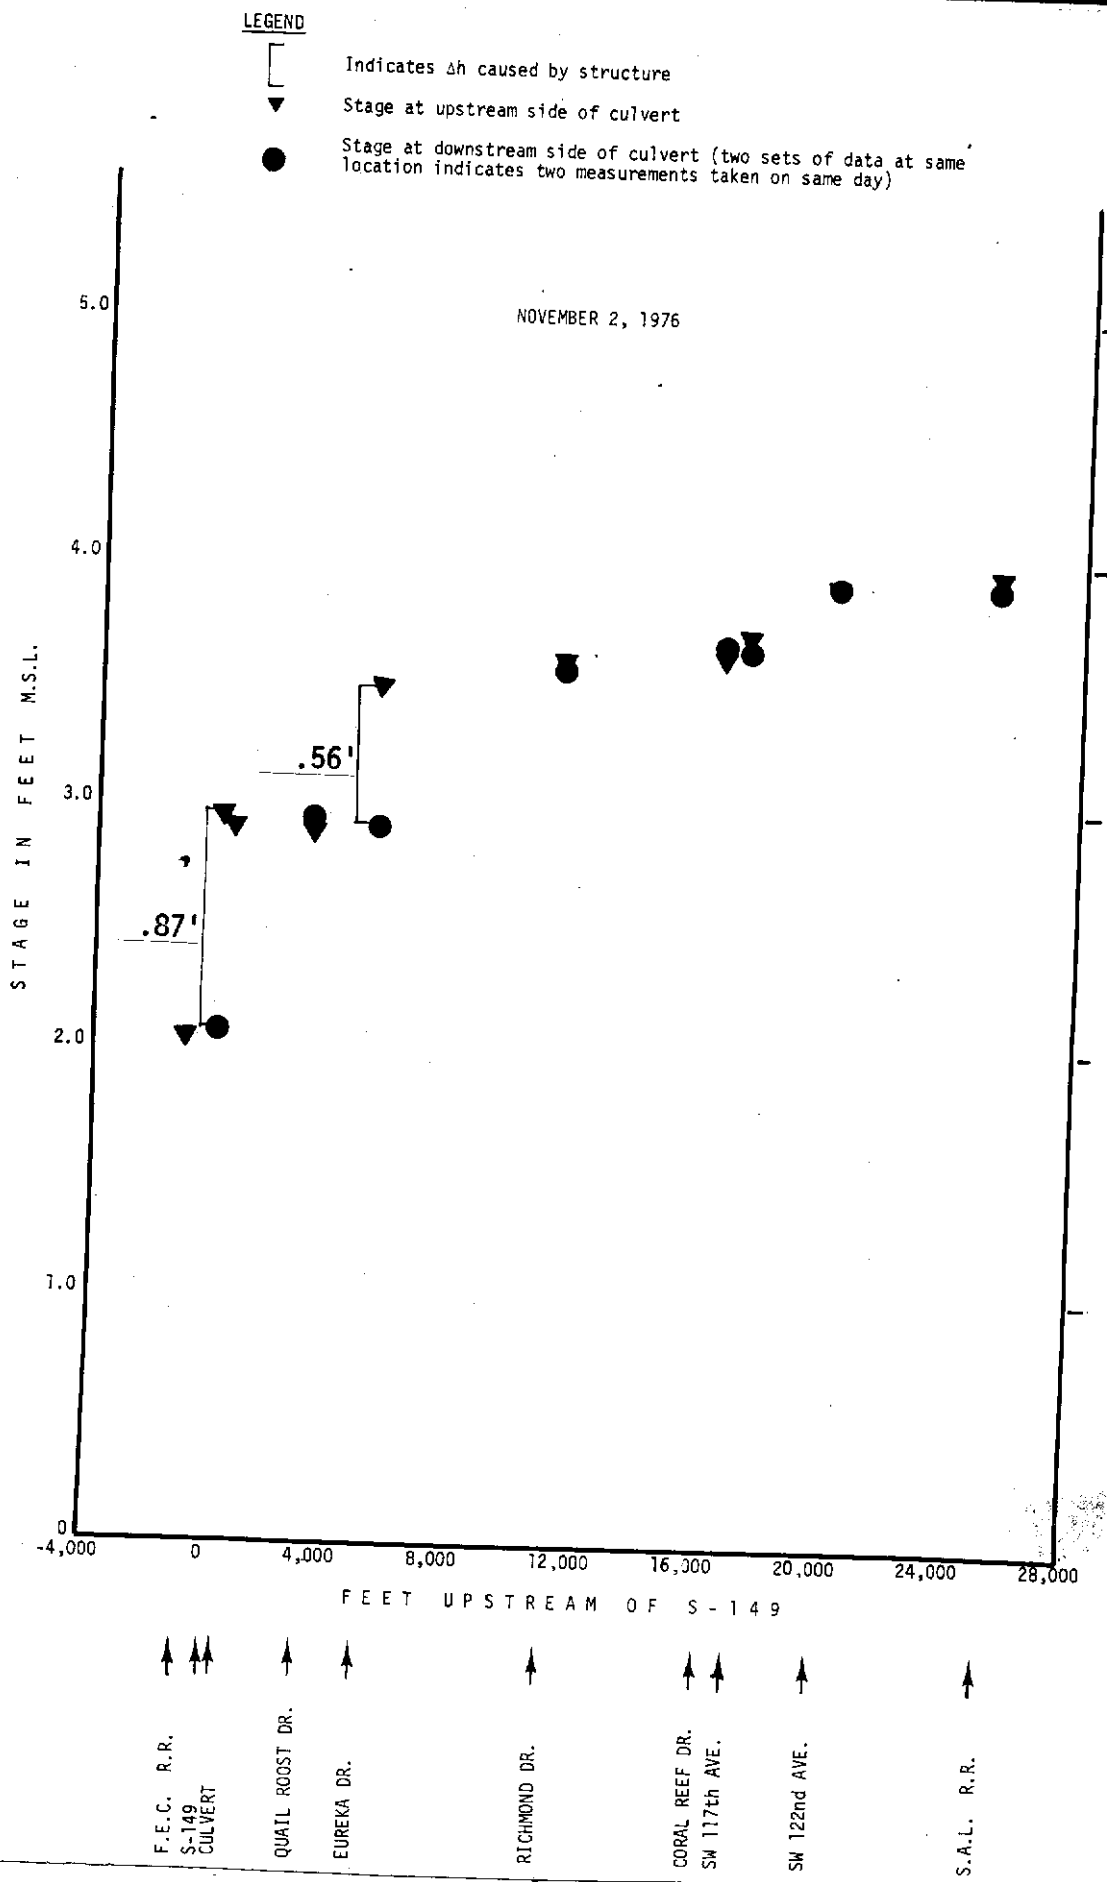
Figure 18. Stage and discharge profiles on November 2, 1976.

Figures 18 to 22 show a reversed hydraulic gradient between Eureka Drive and S-149 when the Eureka Drive structure was in operation. The reason for this is uncertain, but among the possible reasons are: simple measurement error, error caused by wind-induced waves on the water surface, concentration of water at the eastern end by wind action, error introduced in surveying the measurement points, or the existence of an unknown groundwater sink (pumping well) near Eureka Drive. The maximum reversed gradient is about 0.10 feet per mile, and is not considered to detract from the overall quality of data.

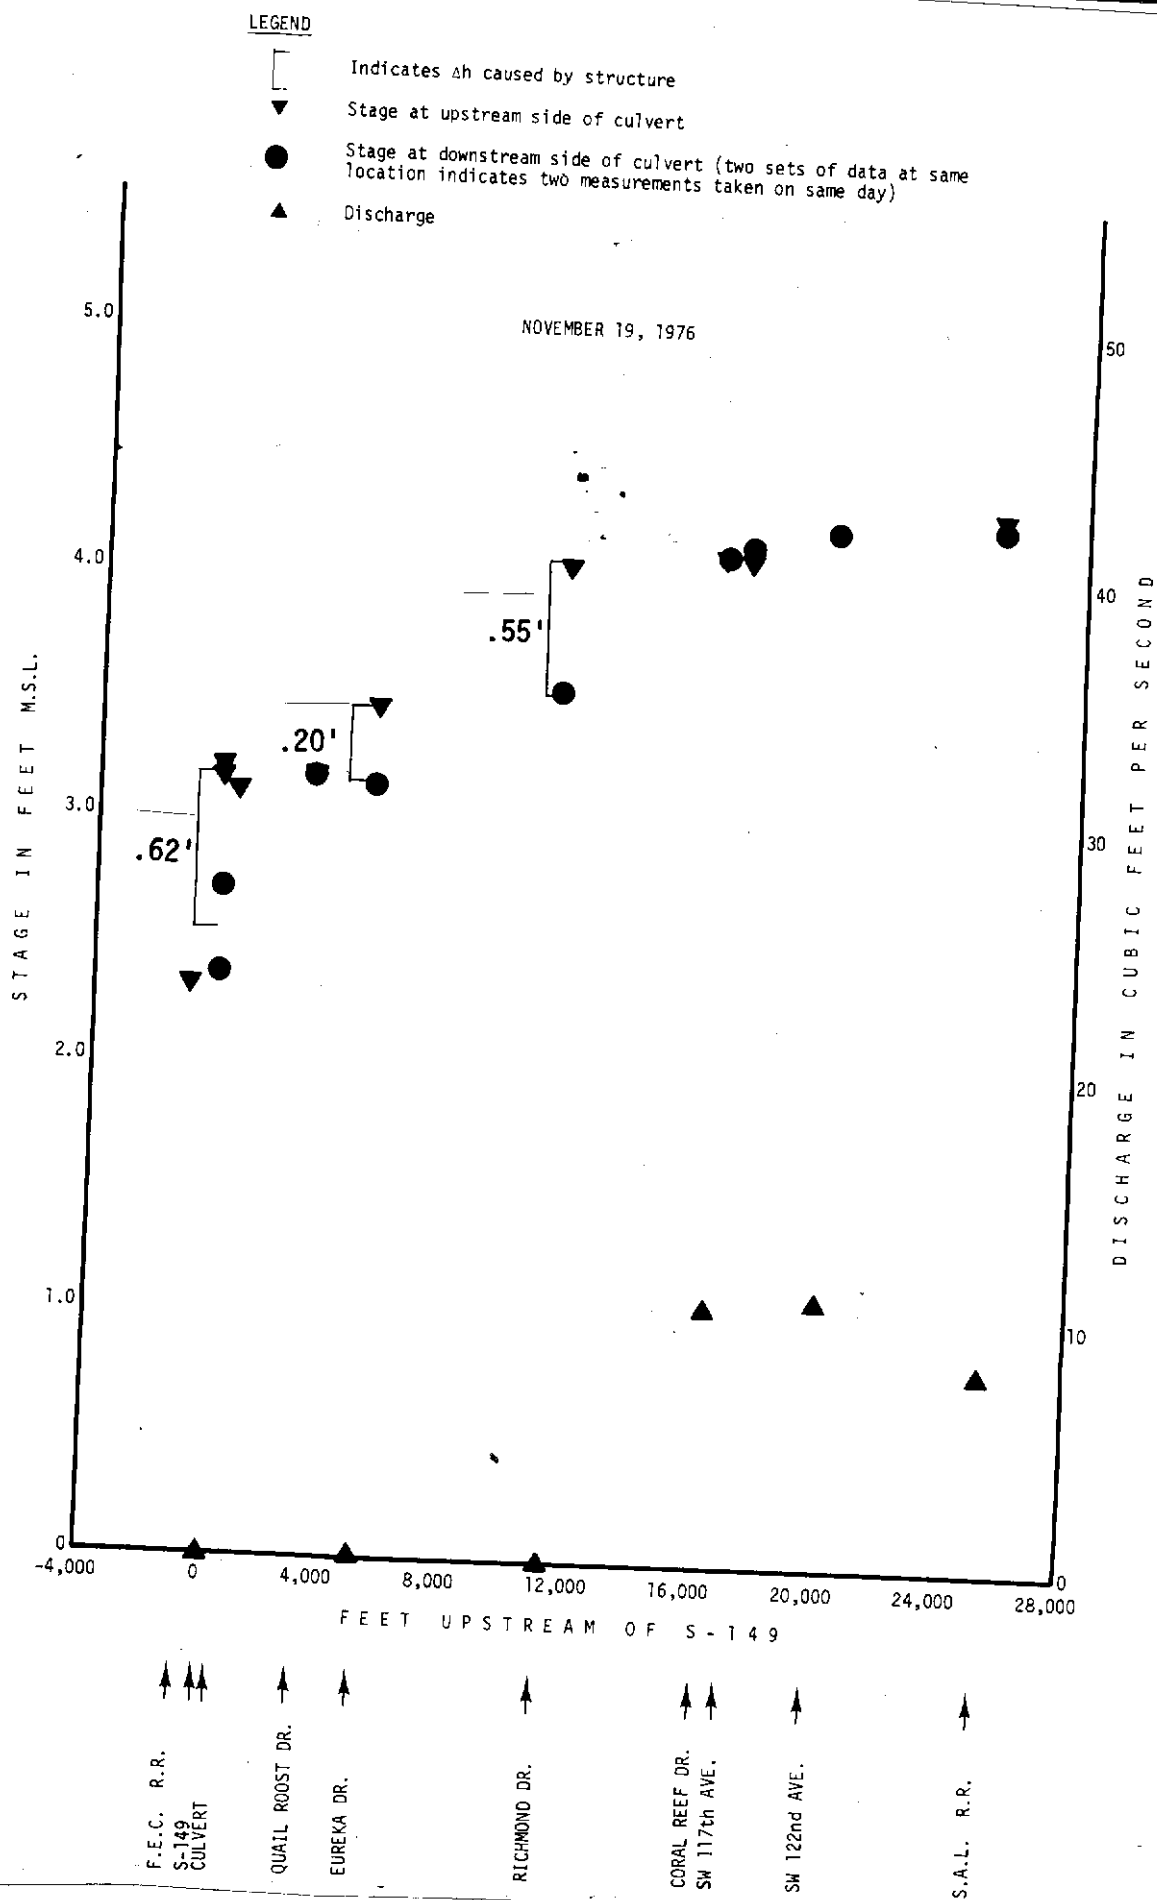
Figure 19. Stage and discharge profiles on November 19, 1976.

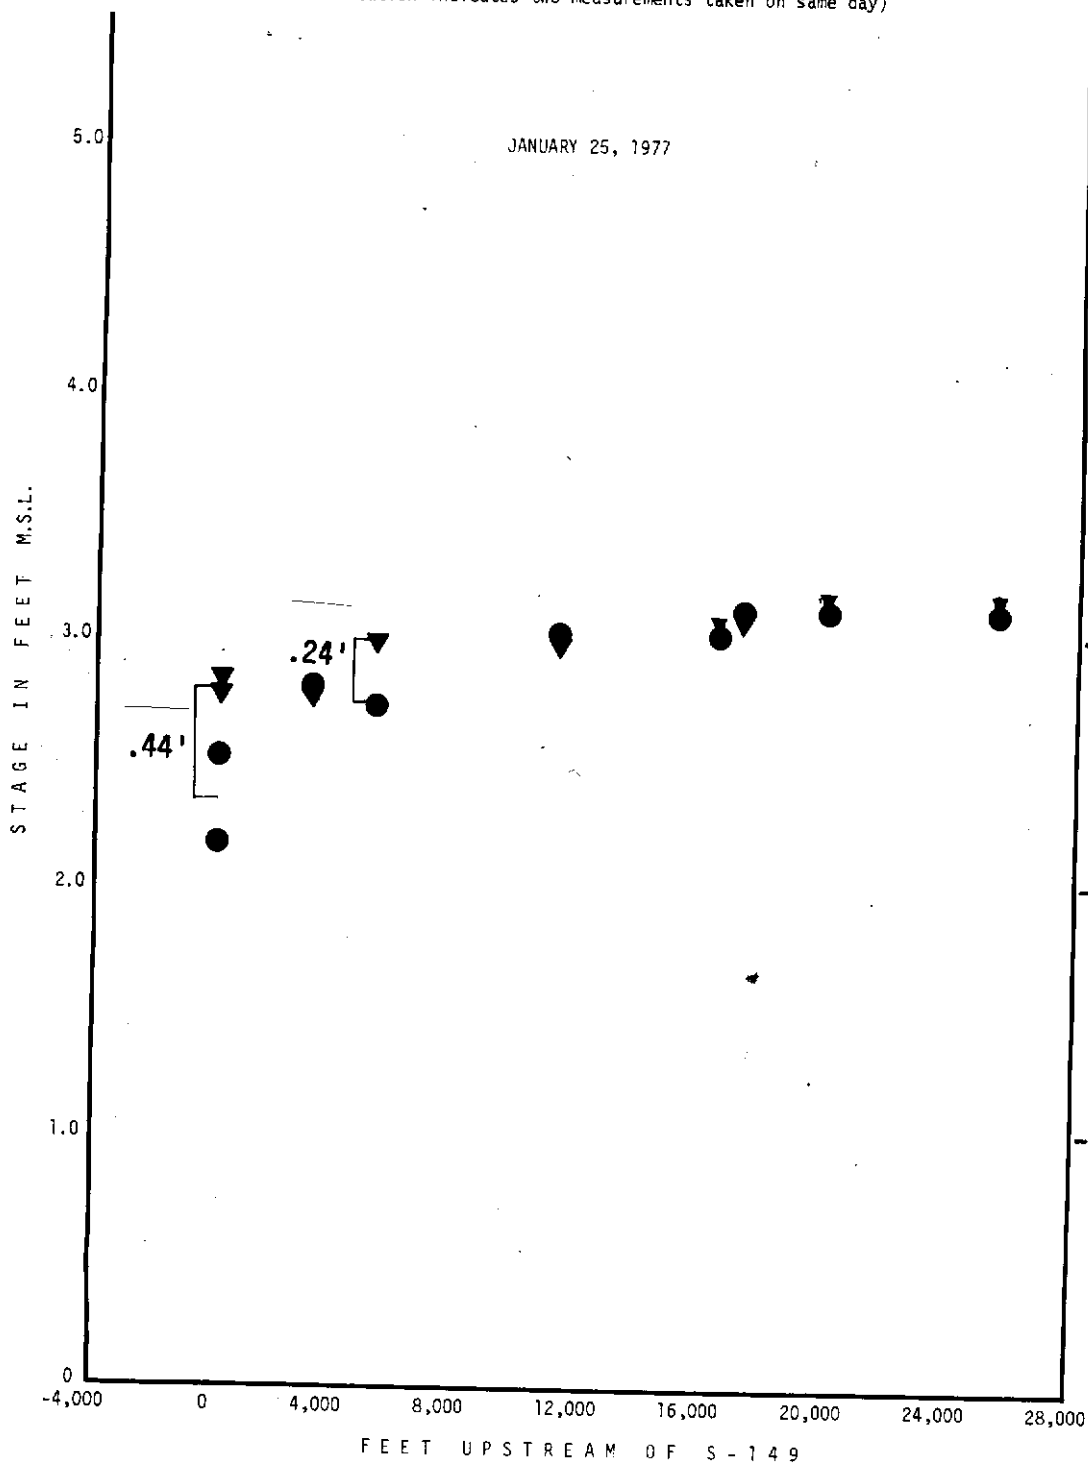
Figure 21. Stage and discharge profiles on January 25, 1977.

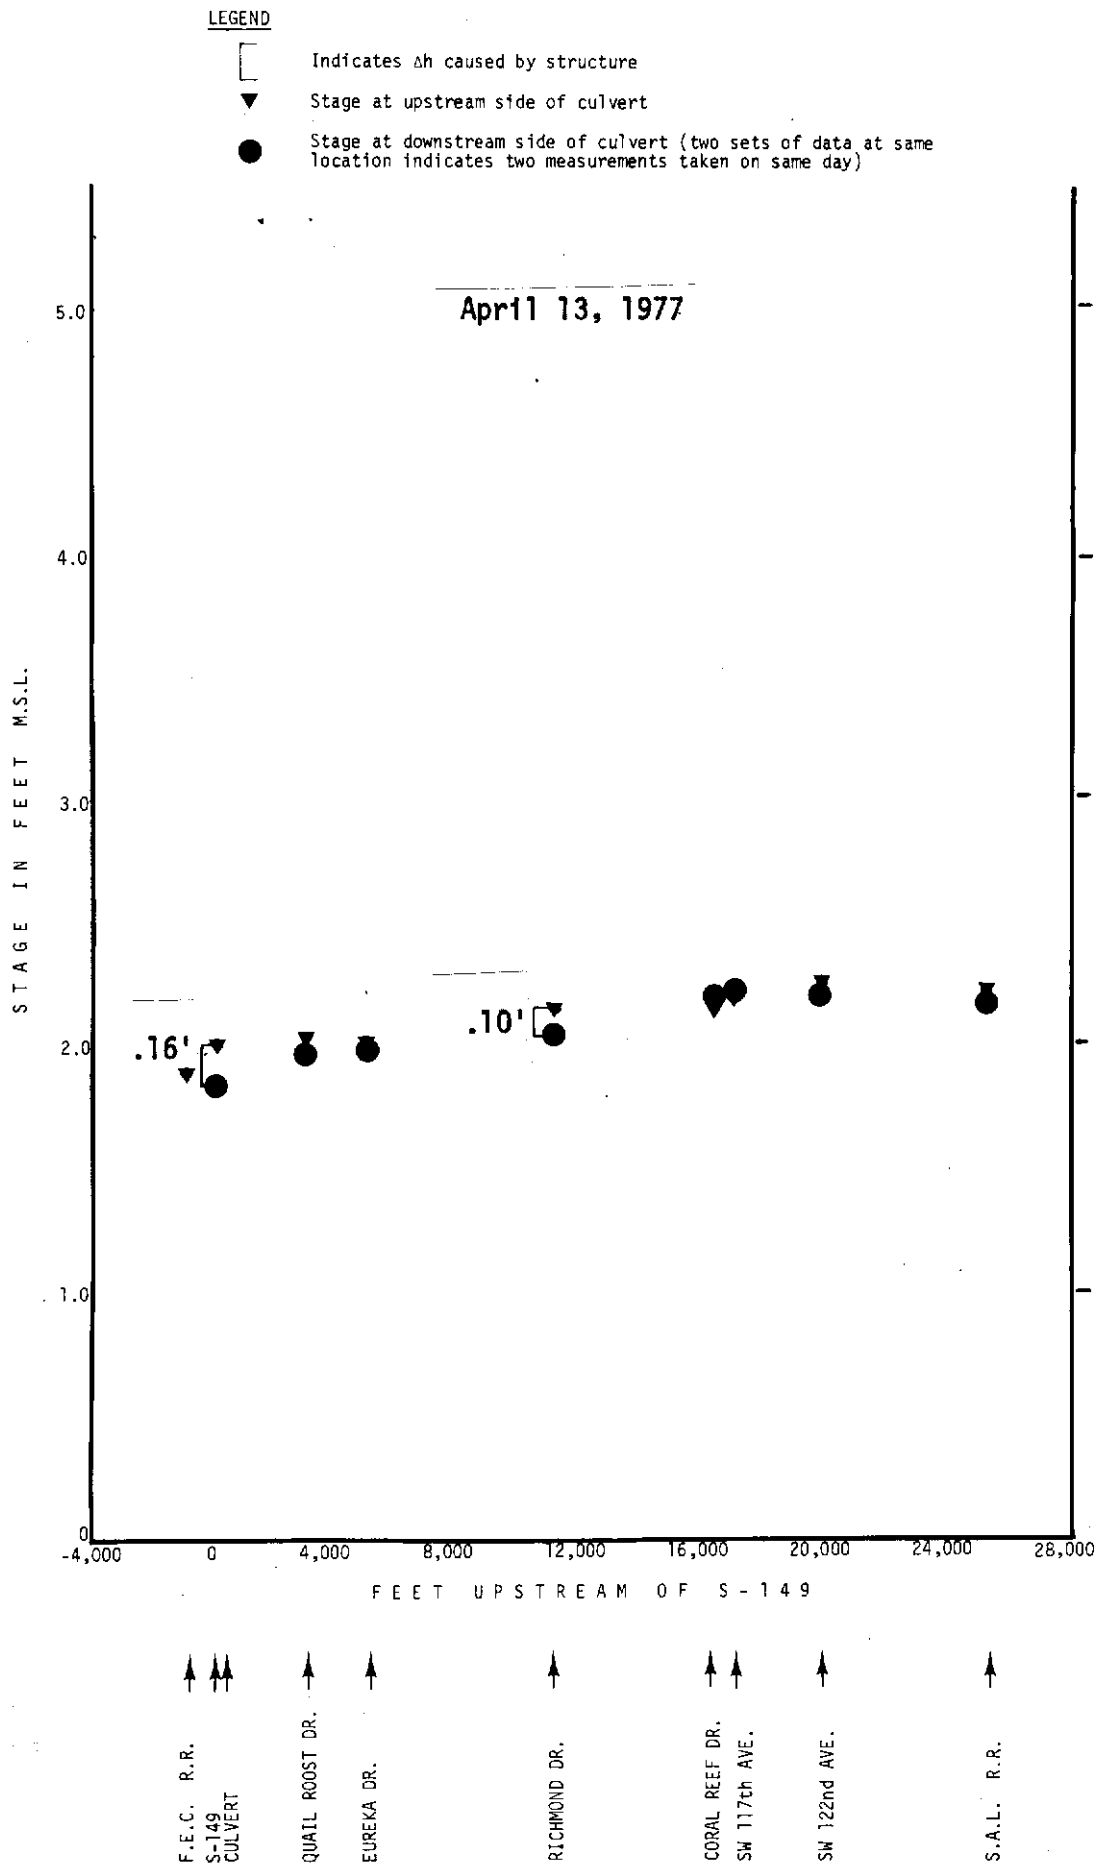
Figure 23. Stage and discharge profiles on April 13, 1977.

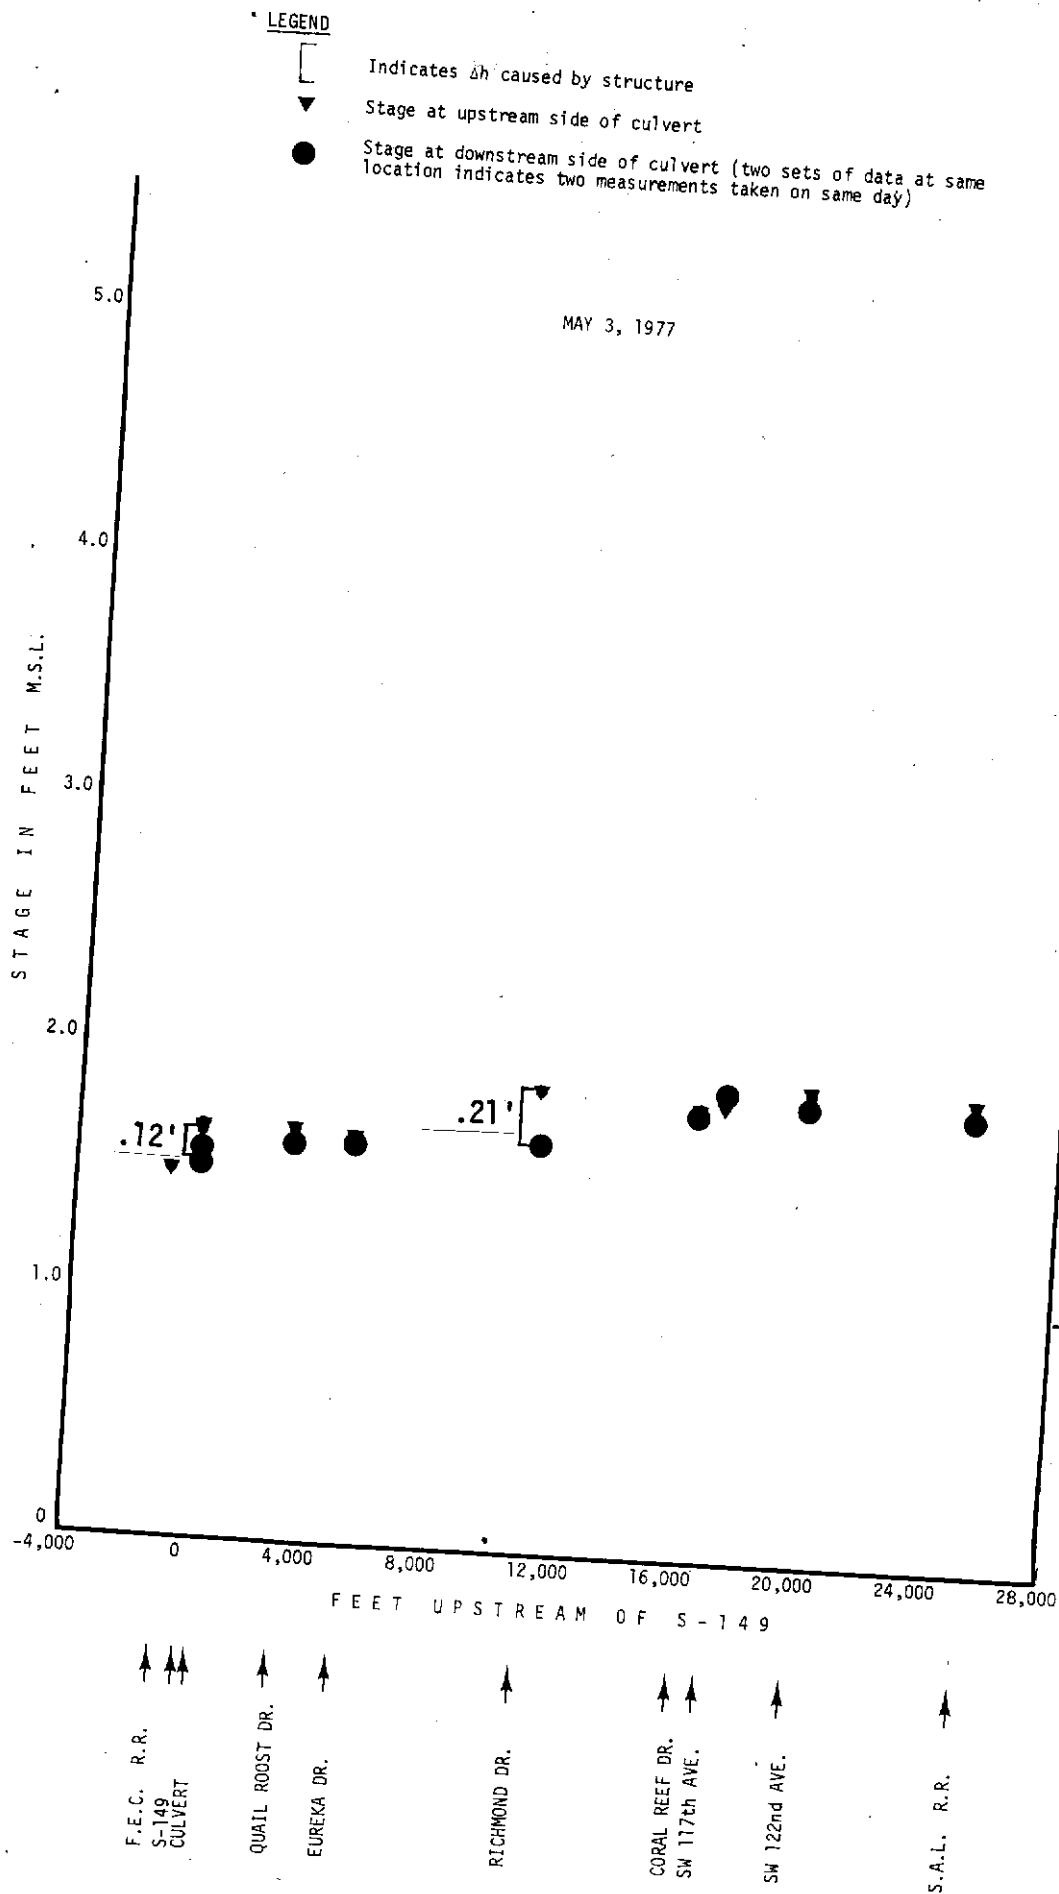
Figure 24. Stage and discharge profiles on May 3, 1977.

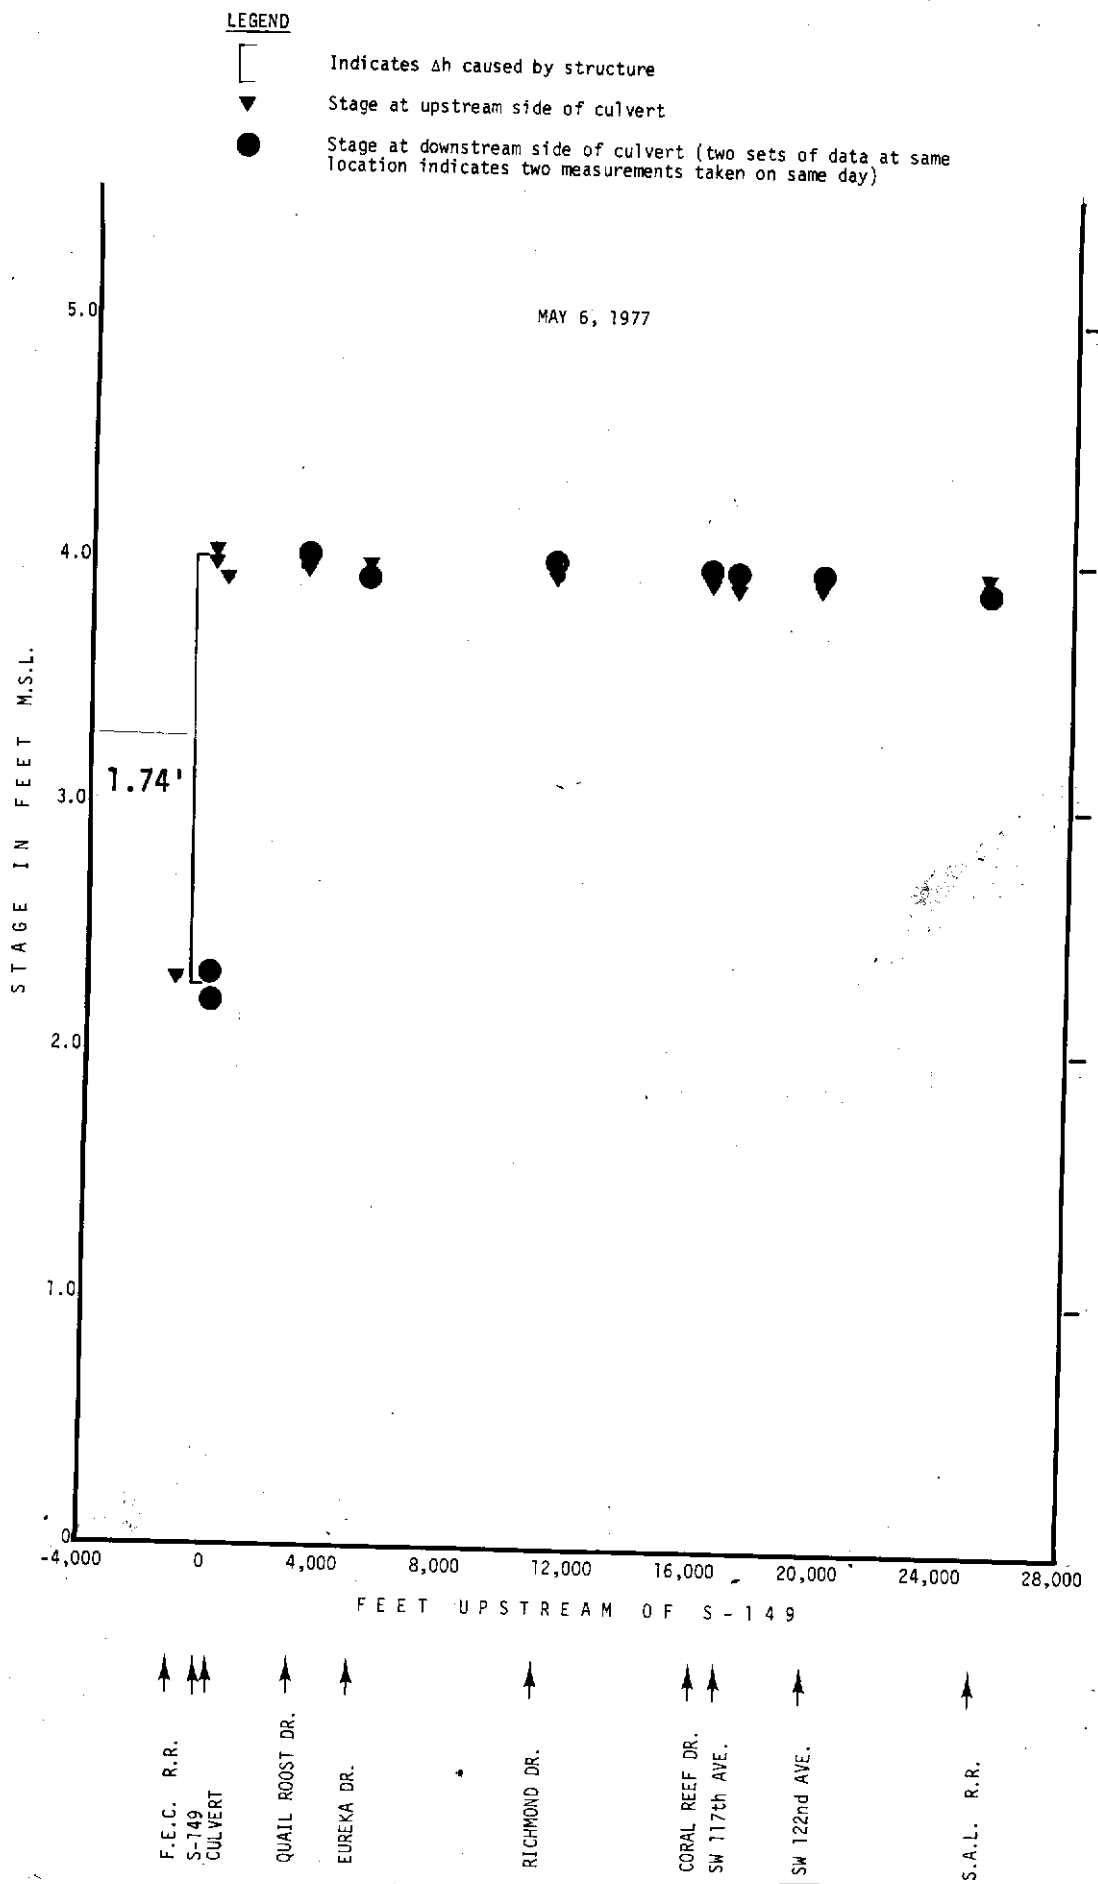
Figure 25. Stage and discharge profiles on May 6, 1977.

Canal stages respond to rainfall events in some unexpected ways. Generally, the canal flow was directed towards S-149 during the study period; however, on May 6, 1977, the flow was directed upstream from S-149 apparently due to the large storage capacity provided by a rock pit adjacent to the canal. This strongly suggests that the basin response to rainfall is not uniform. Unusually heavy or a nonuniformly distributed rainfall would likely require several days for near steady-state equilibrium conditions to develop throughout the canal system. Thus, the stage data should be considered representative of an instant in time as taken from a constantly varying time-dependent system. Daily stage differential data collected at the temporary structures for the purpose of structure site comparisons, suggest that stages require up to 5 days for stabilization after a structure is placed into operation.

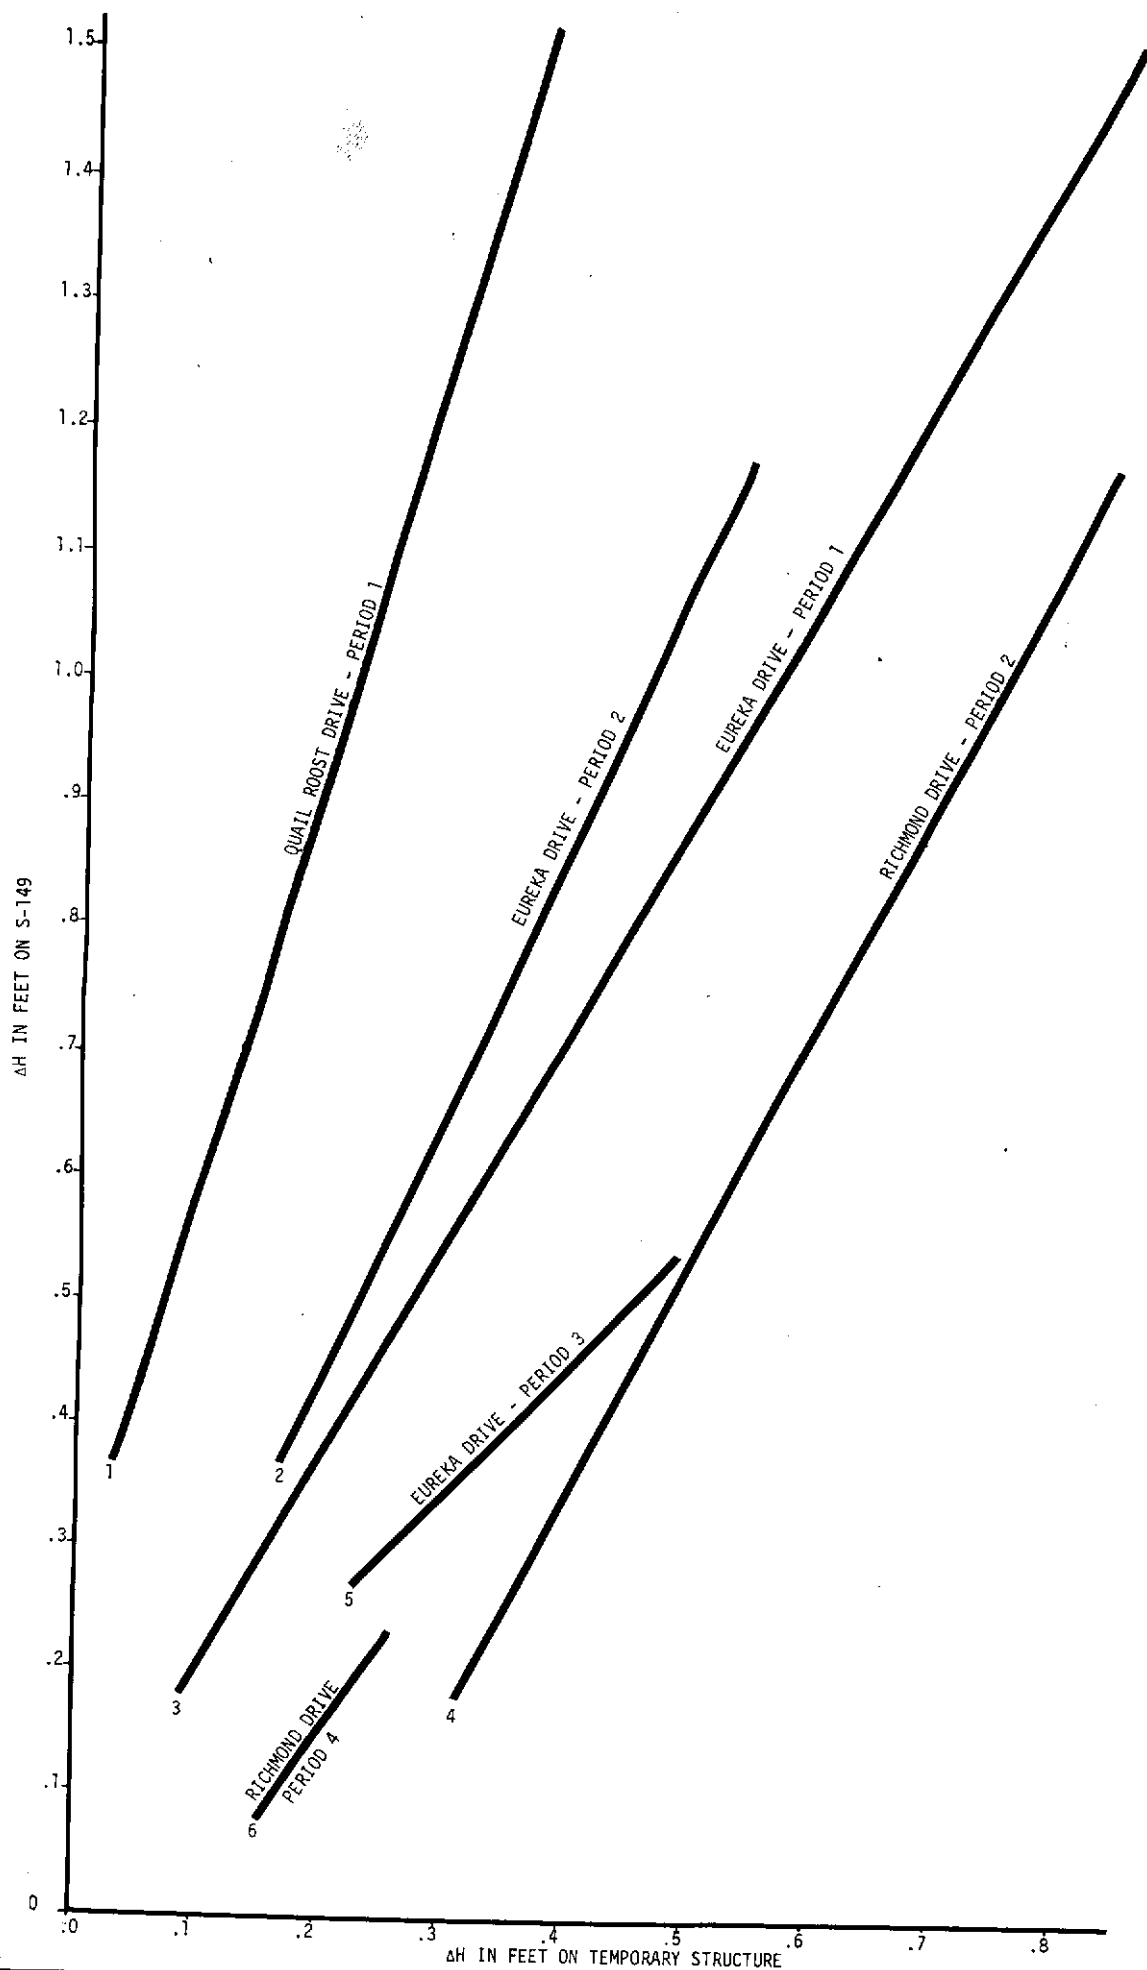
Figure 26. Regression lines formulated from Δh data during four collection periods. Relationships shown are Δh at S-149 vs. Δh at Quail

In the first data collection period, the structures at Quail Roost Drive and Eureka Drive were simultaneously compared with S-149 as depicted on Figure 26, lines No. 1 and 2. The range of Δh in this period was good and a high correlation coefficient resulted (Table 2). The mean Δh at the Quail Roost

site, the Eureka site, and at S-149, were 0.175, 0.462, and 0.866 respectively, indicating a performance order from high to low of S-149, Eureka and Quail Roost. The slopes and intercepts of the regression lines confirm these findings. A slope of 3.373 for the Quail Roost site indicates that for each unit of Δh at the Quail Roost site, 3.373 units of Δh correspond at S-149. A slope of less than one would indicate that the temporary structure site performs better than S-149. The regression line intercept of +0.270 for the Quail Roost site indicates that there must be a Δh of 0.27 feet at S-149 before a Δh at Quail Roost develops, signifying that S-149 performs better than Quail Roost Drive. A negative intercept would indicate that the temporary structure site performs better than S-149. An analysis of the field data was conducted in a similar fashion for the remaining three data collection periods. A summary of results is presented in Table 3.
